zHome Neighborhood
Issaquah, WA

Report #: 26469-9
Beginning: July 1, 2023
Expires: June 30, 2024

RESERVE STUDY
Update "With-Site-Visit"

December 7, 2022

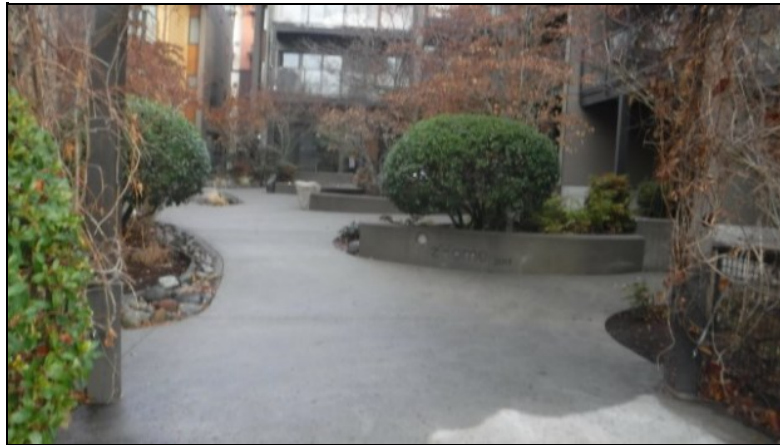
Comp #: 100 Concrete - Repair/Replace

Useful Life:
5 years

Remaining Life:
3 years

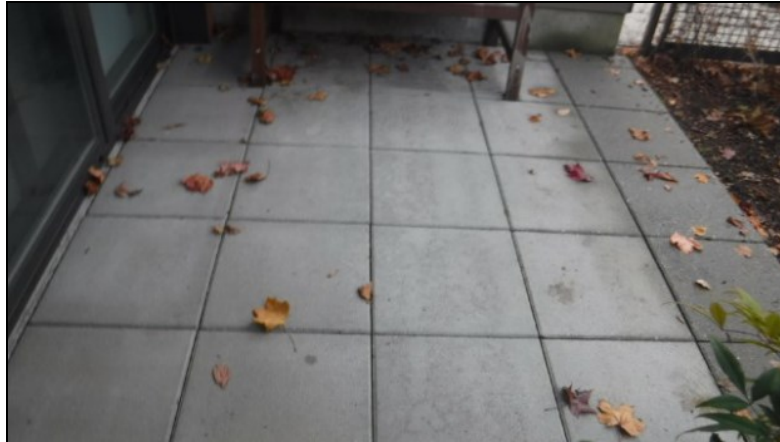
Comp #: 103 Concrete Pavers - Repair/Replace

Useful Life:
5 years

Remaining Life:
3 years
