zHome Neighborhood
Issaquah, WA

Report #: 26469-9
Beginning: July 1, 2023
Expires: June 30, 2024

RESERVE STUDY
Update "With-Site-Visit"

December 7, 2022

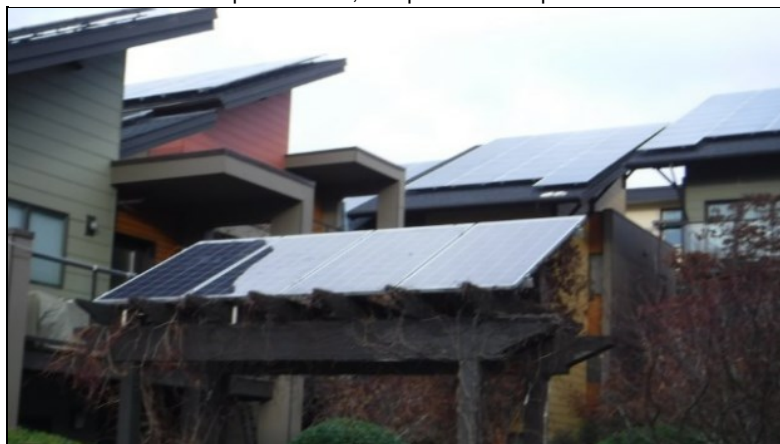
Comp #: 972 Micro Inverters, Solar CA- Replace

Useful Life:
20 years

Remaining Life:
9 years

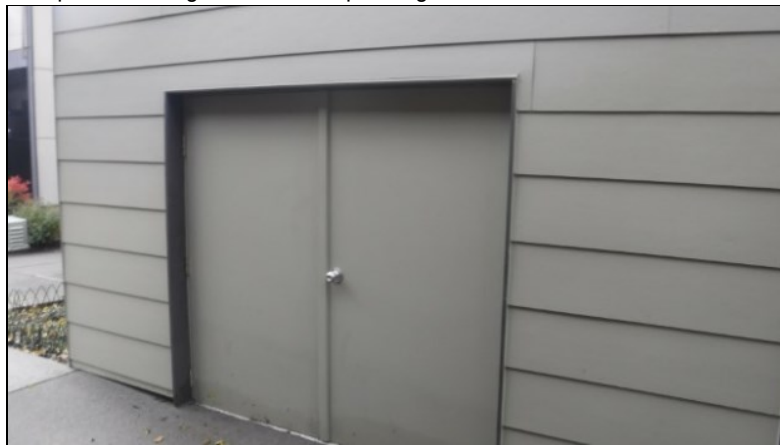
History: Replaced August 2020 due to pump failure

As discussed with NW Mechanical, factored here is replacement of the two large circulating pumps. As part of routine maintenance, inspect regularly and repair/rebuilding as needed as part of general maintenance.

Useful Life:
15 years

Remaining Life:
12 years

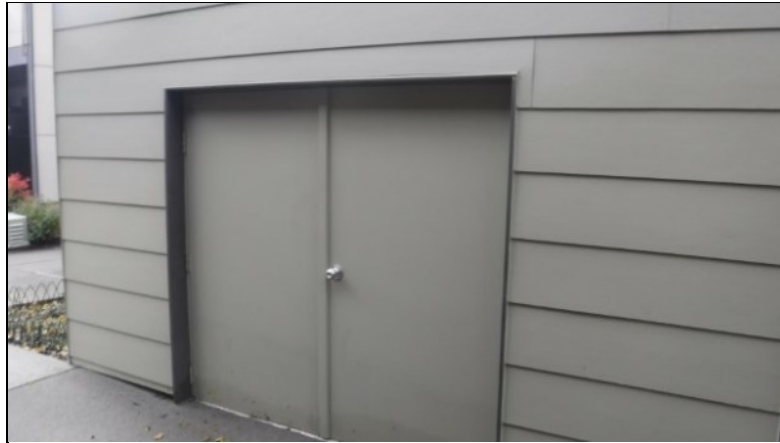
As discussed with NW Mechanical, factored here is replacement of the two large circulating pumps. As part of routine maintenance, inspect regularly and repair/rebuilding as needed as part of general maintenance.

Useful Life:
15 years

Remaining Life:
3 years
