Reserve Study Level I

Prepared for Crofton at Village Green Div 48 & 52

2022 - 2023 Fiscal Year

Prepared by CEDCORE, LLC

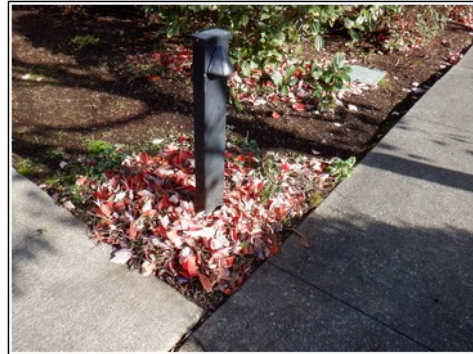
Site/Grounds - 48 Bollard Light: Replace, Phase 1

Location: Pathways
 Quantity: 33 Each
 UL: 30
 RUL: 19
 Current Cost: \$16,500
 Condition: Good
 Funding Basis: Funded based on the typical life expectancy

Good condition with no widespread instability or unusual deterioration noted at this time.

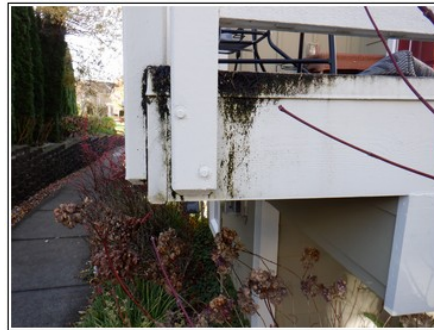
Site/Grounds - 48 Concrete Patios & Porches: Repairs

Location: Throughout
 Current Cost:
 Condition: Good
 Funding Basis: Unfunded, no predictable expectation of expense

Generally good condition. Inspect annually and repair as needed.

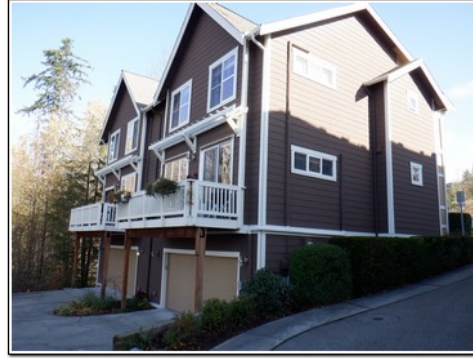
Building Exterior - 48 Decks, Composite: Replace

Location: Throughout
Quantity: 160 Square Feet
UL: 25
RUL: 8
Current Cost: \$8,000
Condition: Unknown
Funding Basis: Funded based on the typical life expectancy

We assume proper construction techniques were utilized including flashings and slope for drainage.

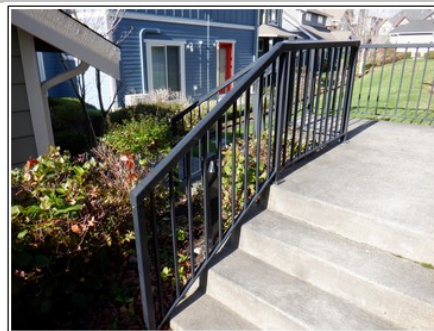
Building Exterior - 48 Guardrail/Handrail: Metal, Replace

Quantity: 120 Linear Feet
UL: 50
RUL: 33
Current Cost: \$10,800
Condition: Good
Funding Basis: Funded based on the typical life expectancy

Good condition with no reported or observed instability noted during our limited scope visual inspection. Clean as needed for appearance (these units are powered coated and therefore there is no need for paint). We recommend ongoing and regular examinations, particularly the connections. We recommend planning for eventual replacement.

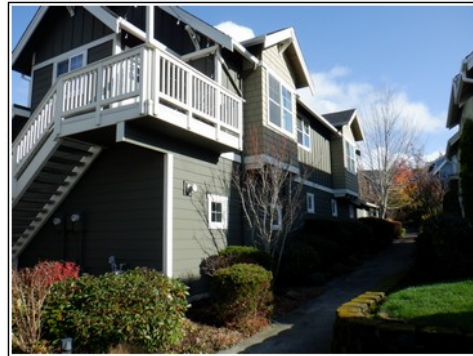
Building Exterior - 48 Guardrail: Wood, Replace

Location: Carriage House and Hillside Cottages
 Quantity: 470 Linear Feet
 UL: 25
 RUL: 8
 Current Cost: \$25,900
 Condition: Fair
 Funding Basis: Funded based on the typical life expectancy

Fair condition with no reported or observed instability noted during our limited scope visual inspection. Clean and repaint as needed for appearance and protection of the wood. We recommend ongoing and regular examinations, particularly the connections to the deck platform. We recommend planning for eventual replacement.

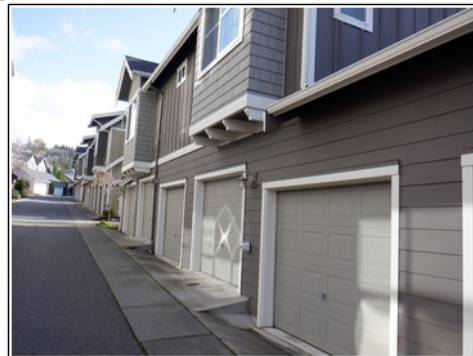
Building Exterior - 48 Gutters & Downspouts: Replacement

Location: Throughout
 Quantity: 3700 Linear Feet
 UL: 25
 RUL: 8
 Current Cost: \$33,300
 Condition: Fair
 Funding Basis: Funded based on the typical life expectancy

No reported problems observed or reported during our site inspection. No widespread damage or indications of early replacement indicated. In general keep clean and free of debris to ensure proper functionality. Reserve funding recommended for replacement timed to coincide with roof replacement projects for cost efficiency.

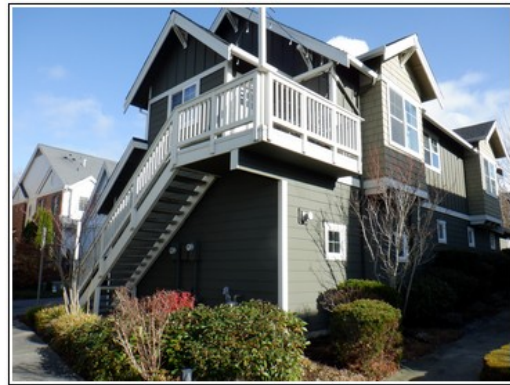
Building Exterior - 48 Landings, Vinyl: Replace

Location: 2nd Floor units of Carriage House Units
Quantity: 1250 Square Feet
UL: 20
RUL: 3
Current Cost: \$15,000
Condition: Functional
Funding Basis: Funded based on the typical life expectancy

The landings utilize a glued down vinyl membrane for weatherproofing and protection of the structure. Currently the surface of the landings are in generally fair condition. These surfaces are extremely important and need to be replaced at approximately 15 to 20 years of age as the vinyl becomes oxidized, brittle and the seams fail. Without replacement there is a significant risk of water intrusion to the deck and surrounding structure.

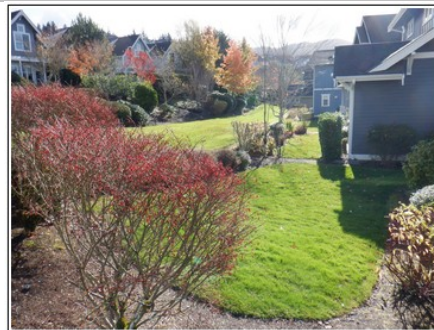
Site/Grounds - 48 Landscaping: Refurbish

Location: Throughout
Quantity: 1 Allowance
UL: 3
RUL: 2
Current Cost: \$2,000
Condition: Assorted Condition
Funding Basis: Funded for repair

This component may be used to fund large landscape projects not budgeted within the operating funds. We understand there is no desire to fund this within reserves at this time. Therefore, no reserve funding.

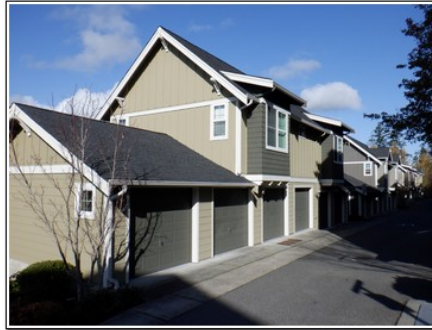
Building Exterior - 48 Roof: Inspect & Clean

Location: All Unit Roofs
 Quantity: 31000 Square Feet
 UL: 3
 RUL: 1
 Current Cost: \$4,272
 Condition: Unknown
 Funding Basis: Funded for repair

Last done in 2016/2017 and 2013/2014.

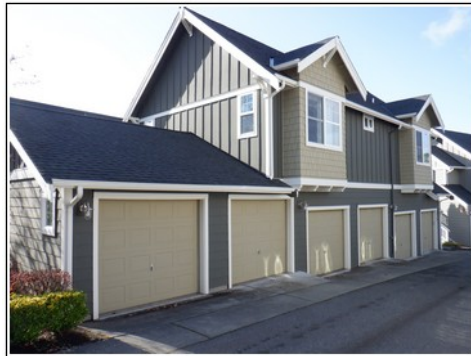
Building Exterior - 48 Roof: Replace

Location: All Unit Roofs
 Quantity: 37400 Square Feet
 UL: 25
 RUL: 8
 Current Cost: \$215,000
 Condition: Unknown
 Funding Basis: Funded based on the typical life expectancy

Assumed to be in fair condition, based on age, with no known concerns or issues reported or observed during our limited ground level inspection. Regular inspection from qualified roofing professional is recommended to avoid any leaks from premature failure. Composition shingles should last full life with regular yearly moss removal, visual inspections and proper maintenance.

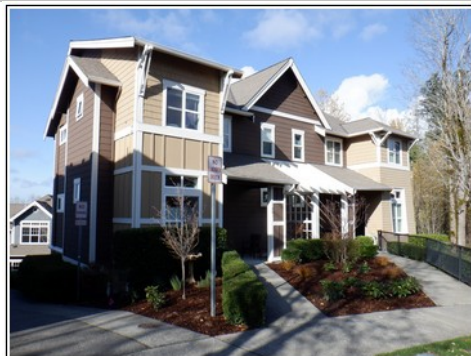
Building Exterior - 48 Siding: Hardiplank, Replace

Location: Throughout
 Quantity: 50330 Square Feet
 UL: 50
 RUL: 33
 Current Cost: \$1,210,000
 Condition: Good
 Funding Basis: Funded based on the typical life expectancy

Generally good condition with no known water intrusion or concerns. We strongly recommend regular inspections and repair to ensure waterproofing of the building envelope. Reserve funding recommended for eventual replacement at the typical life expectancy of 40 to 60 years. Should patterns of repair arise, additional funding may be included in future reserve studies, however, at this time there is no need.

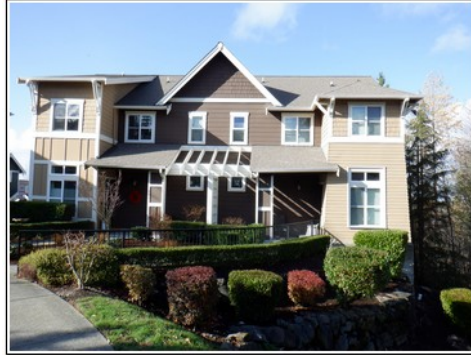
Building Exterior - 48 Siding: Repair

Location: Throughout
Quantity: 50330 Square Feet
UL: 10
RUL: 7
Current Cost: \$151,000
Condition: Good
Funding Basis: Funded based on the typical life expectancy

Last done in 2019/2020. Good condition at this time with no unusual or significant peeling or fading of exterior surfaces. Regular paint cycles are important to maintaining and protecting the building siding and weatherproofing. Inspect regularly touch up paint and caulking as needed from the operating budget.

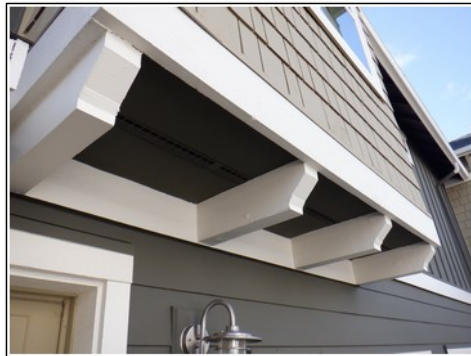
Building Exterior - 48 Siding: Repair

Location: Throughout
Quantity: 1510 Square Feet
UL: 10
RUL: 7
Current Cost: \$20,000
Condition: Good
Funding Basis: Funded based on the typical life expectancy

Funded for repairs or partial siding replacement ahead of each repainting cycle as needed.

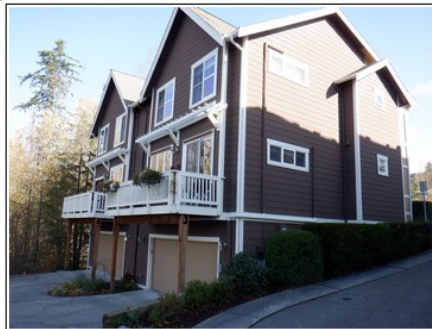
Building Exterior - 48 Sliding Glass Doors: Replace

Location: Throughout
Current Cost:
Condition: Functional
Funding Basis: Unfunded, not Association responsibility

Unit Owner responsibility

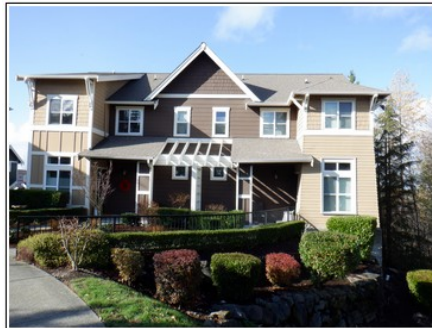
Site/Grounds - 48 Trellis

Location: Entry Stair at Hillside Cottages & Front & Sides of Town Homes

Condition: Fair

Below threshold for inclusion in Reserve Study.
